FINAL REPORT

Lane Events Center – ICE Center

796 West 13th Avenue

Lane County

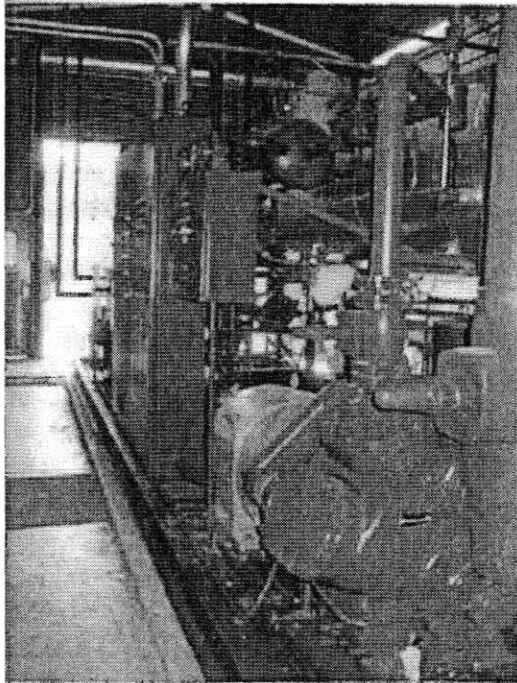
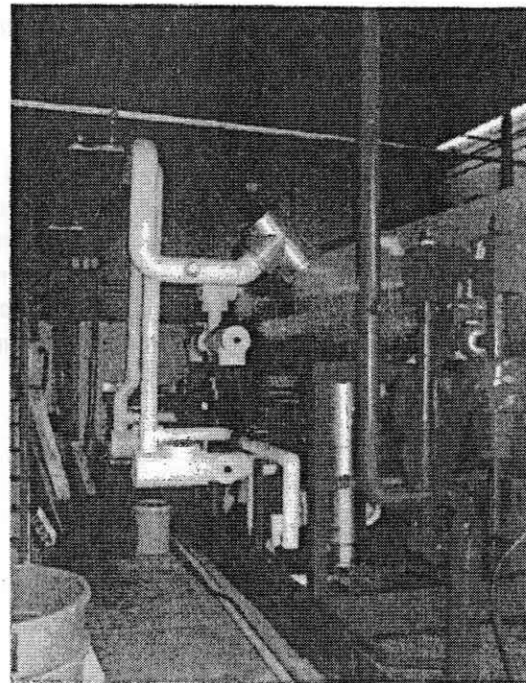
Direct (Liquid Overfeed) Refrigeration System

The existing mechanical system is "Direct System" as designed by Bonestroo, Rosene and Anderlik of St. Paul, Minnesota. It was installed in 1989 by Holmsten Ice Systems. The system capacity is about 135 tons. At the time this unit was installed, it was considered state of the art. When a facility considers replacing a direct system (with any indirect system), it must be understood that the direct system is at least 20% more efficient than any indirect system on the market. It is also noteworthy that this system at The Events Center has been extremely well maintained and is in excellent condition. The main issue is the failure of the under slab heating grid.

The refrigerated skating surface is 192ft. X 85ft. with 28ft. radiused corners. Under this slab is the sub floor heating grid. In the slab is the refrigerated piping grid. By design, some of the heat being rejected by the compressors is piped through a heat exchanger, collected and pumped under the refrigerated floor to a set of PVC manifold headers. These headers distribute the warm glycol solution. This heating loop is usually a mixture of water and anti freezing agent. In this case, (according to the original drawings) it would contain a 40% mixture of propylene glycol and water. Originally the charge of this loop would be about 450 gallons. While in operation the propylene glycol temperature would be 40 to 45 deg F water and circulated by a 2hp pump. This under floor heating system was designed to keep the sub base of the rink area above freezing, thereby eliminating frost buildup.

In this application the contractor used 2.5" PVC headers to distribute the warm glycol. A flaw in the design is that as the headers transitioned to the actual run outs, steel nipples were used at the point of connection. This connection is shown on Dwg. 3, detail E-3. Overtime these nipples have had a tendency to break down and leak.

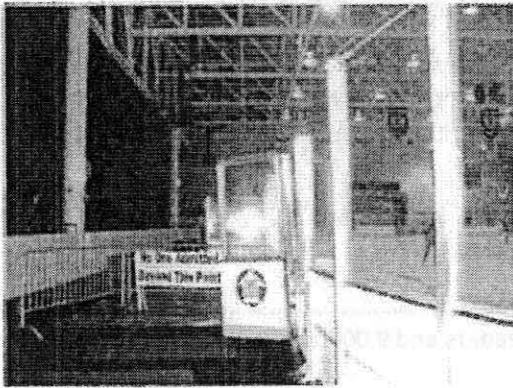
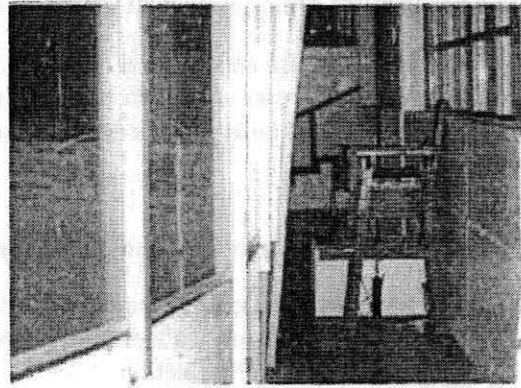
Dasher Board System

The dasher system is in very poor condition. If a decision is made to continue skating, we strongly suggest that some immediate remedial work be done on the boards. At the very least all of the openings where sticks, legs, hands, elbows or heads could go through must be eliminated. The most dangerous points exist at most of the gate. Knee bracing and supports should be added wherever necessary.

The dasher system is beyond repair and should be totally replaced.
