AGENDA ITEM TITLE: REPORT BACK-PERKINS CREEK BRIDGE ON BIGGS ROAD
(A LOCAL ACCESS ROAD).

Preliminary Options Analysis

Biggs Road Bridge MP 0.20

Biggs Road, MP 0.2
Bridge Repair/Replacement

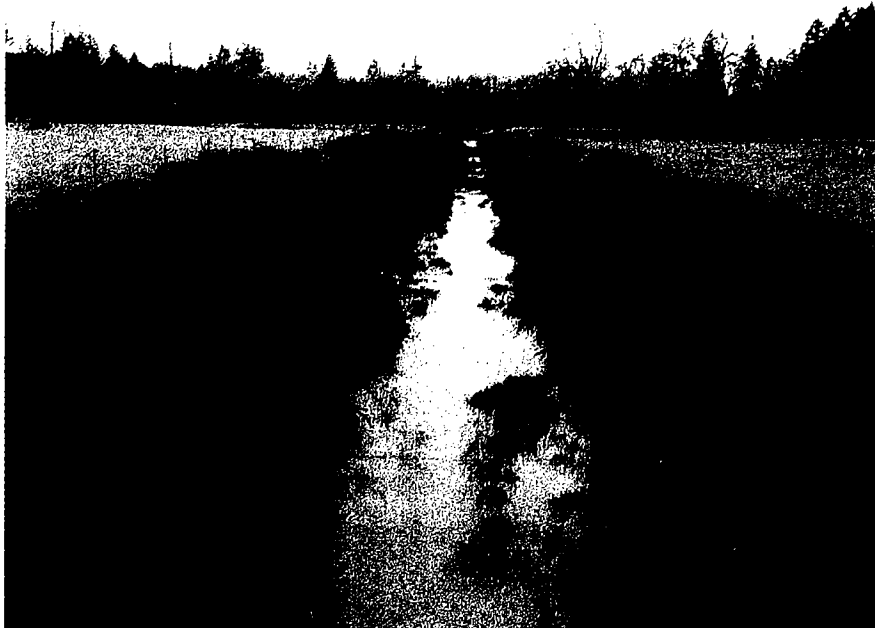
View Looking Upstream of Bridge

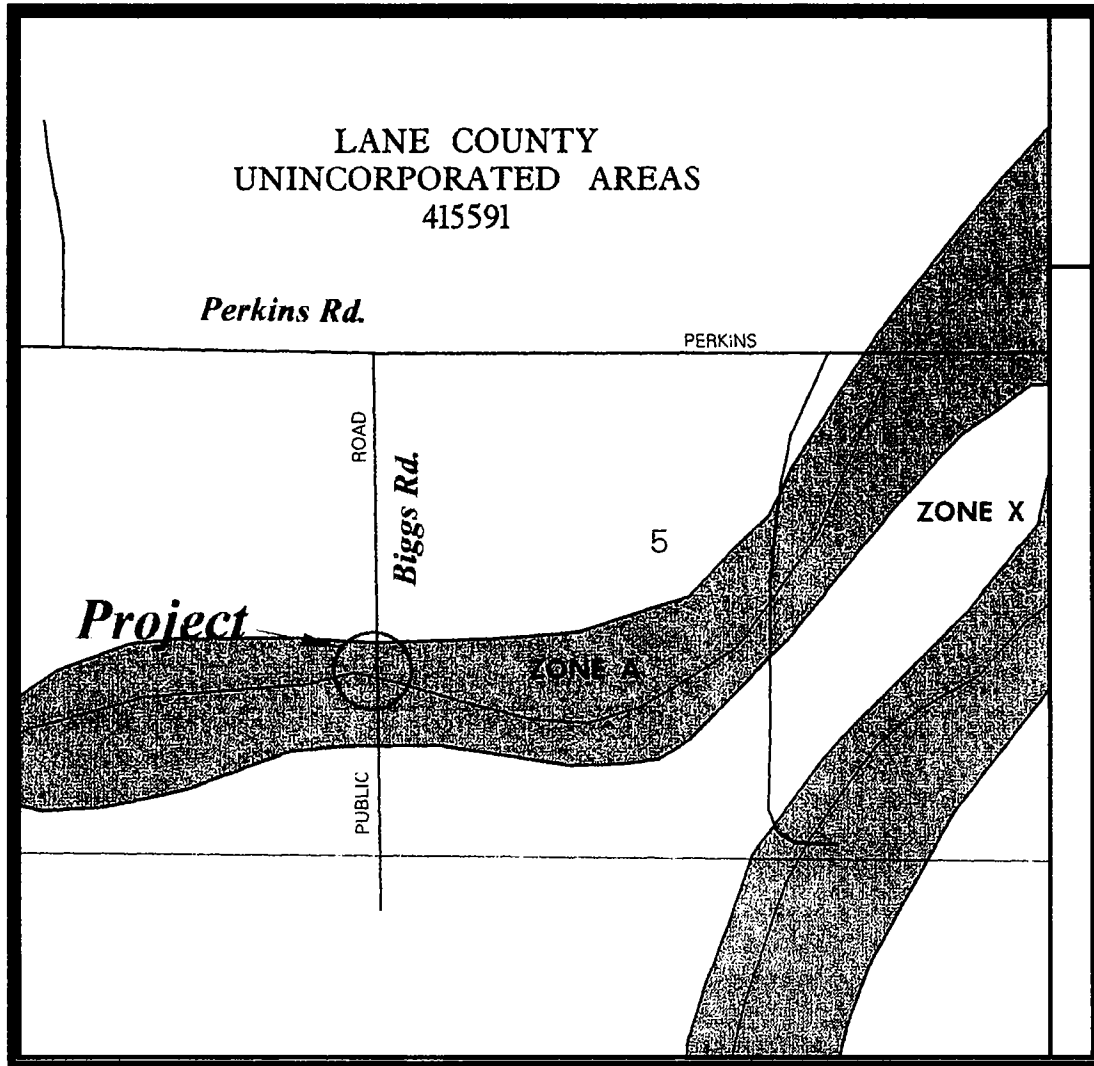
Appendix 1 – Flood Zone Map

FIRM No. 41039C1087 F

The project site is within the 100-year flood zone as shown on Flood Insurance Rate Map (FIRM) No. 41039C1087 F. The 100-year flood zone at the bridge is about 270 feet wide. A flood study was not conducted for this stream reach, and no base flood elevation for the 100-year flood has been calculated. It is likely that the 100-year flood zone boundary (Base Flood) was determined from aerial photos taken during a flood event, prior to the construction of the channel improvements in 1965. See Appendix 1 – Flood Zone Map.
