Vegetation Division – Lane County Department of Public Works

TOPIC: VEGETATION FABRIC TEST PROJECT

Vegetation Management Program, Alternative Control Test Project Summary

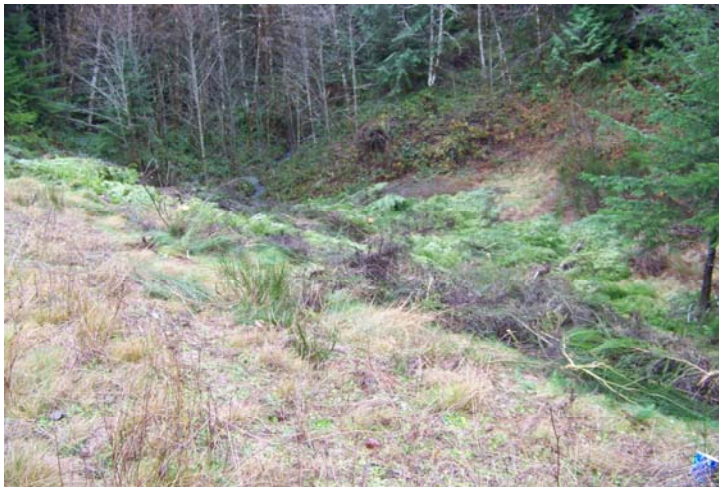
Picture 1

Shows some of the area being grubbed of Scotch Broom

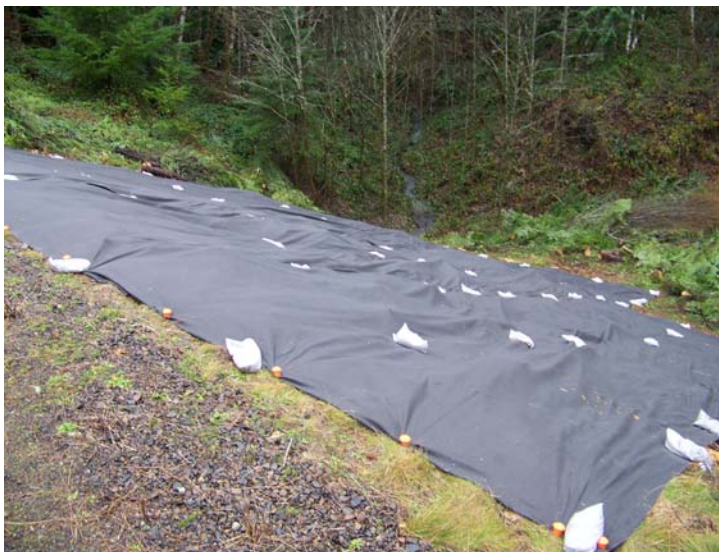
Picture 2

Showing the fabric installed with sandbags and rebar to hold fabric in place

Both project sites were manually grubbed of all vegetation down to the height of the existing grass communities. After the grubbing process felt fabric was placed over the grubbed areas to test the ability of the material to prevent the re-growth of these species at the project sites. All of the fabric was held in place with two foot rebar posts covered with over two hundred and seventy five sandbags to prevent re-growth from pushing up the fabric or weather events from moving the fabric.

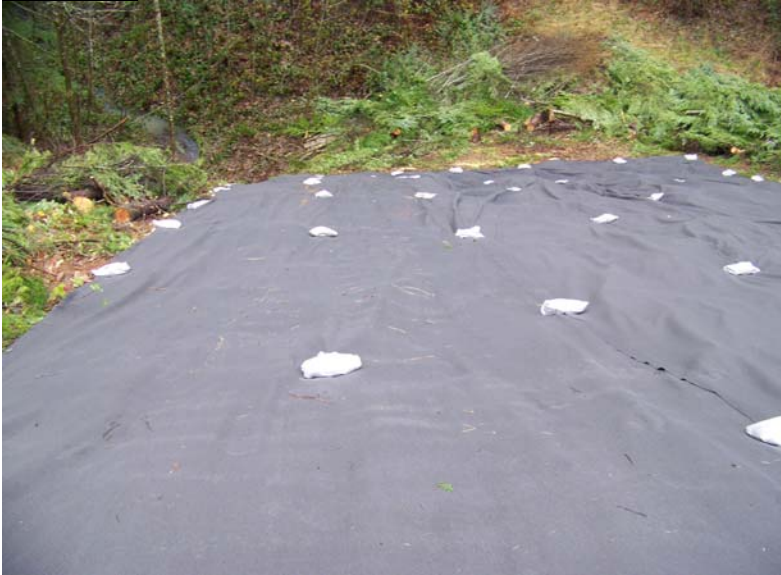
Picture 3

Shows the area cleared of fir trees and Scotch Broom with fabric installed over project area.

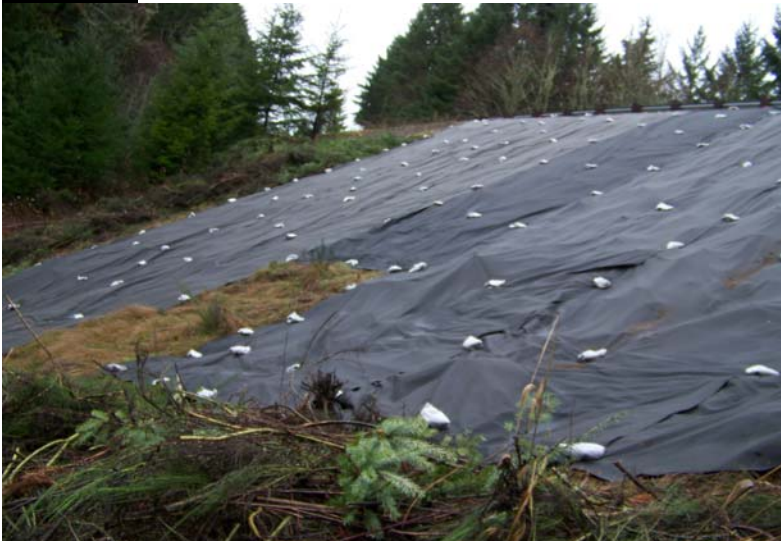
Picture 1

A view from the bottom of the project area after the fabric was installed.

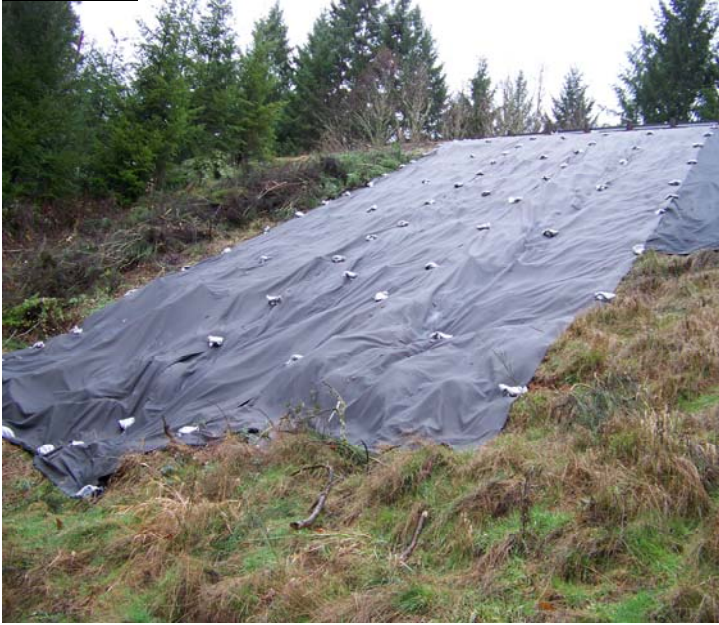
Picture 2

Western half of the project area
with portions of the grubbed weeds

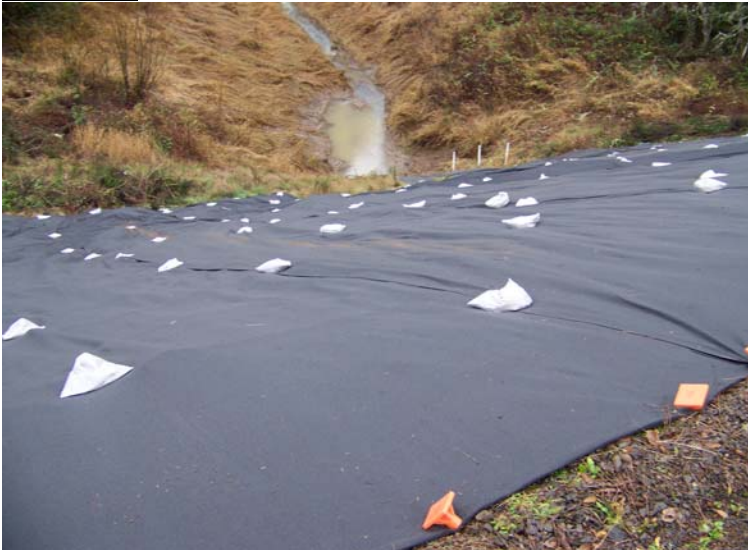
Picture 3

Shows the sandbags and rebar
with safety caps that was used
to hold the fabric in place.
